PORTAPEDANE

MATERIALE DI COSTRUZIONE lega di alluminio 2024, acc. Inox AISI 303  
LAVORAZIONI fresatura e tornitura CNC  
TRATTAMENTI SUPERFICIALI ossidazione anodica colore

FOOTPEGS HOLDERS

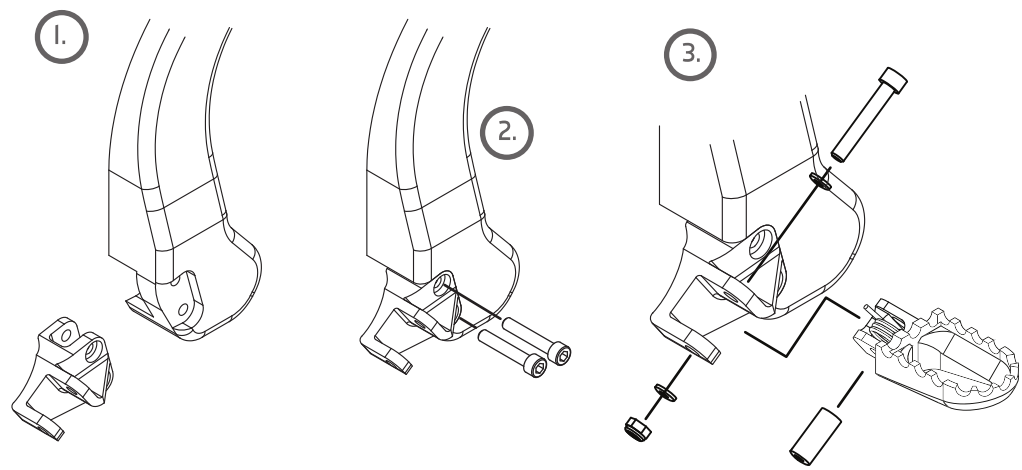
- 1.
- 2.
- 3.

assemblare i portapedane sul telaio come mostrato in figura utilizzando la bussola e le viti fornite;

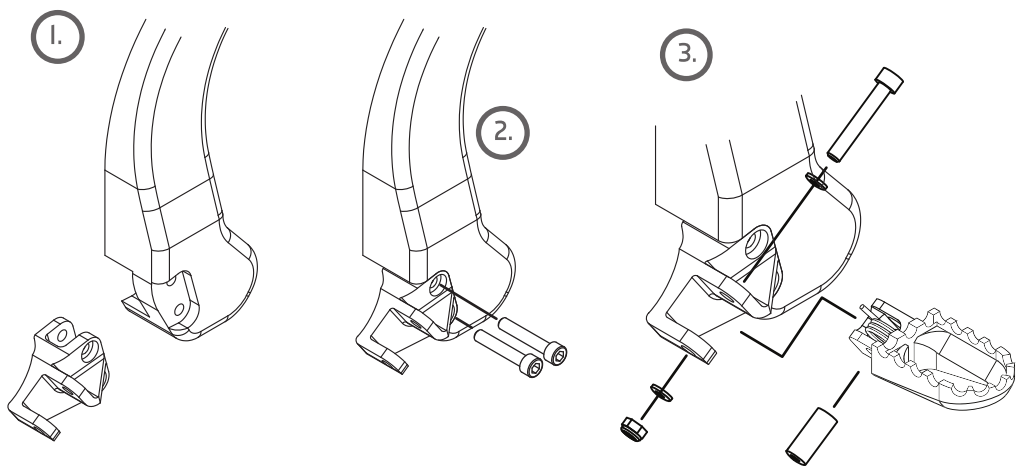
- 1.
- 2.
- 3.

assemblare i portapedane sul telaio come mostrato in figura utilizzando la bussola e le viti fornite;

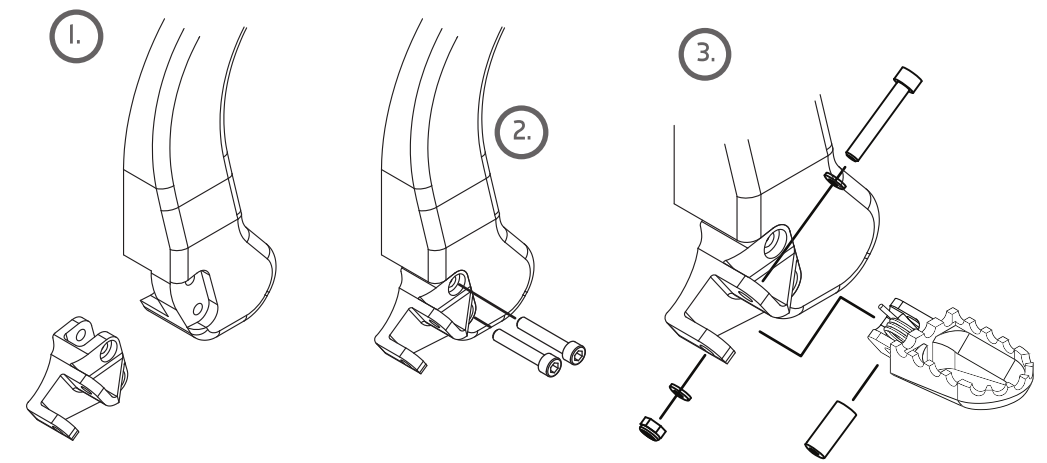
1. 2. 3. assemble on the footrest on the frame as shown in figure using the bushing and the screws provided;

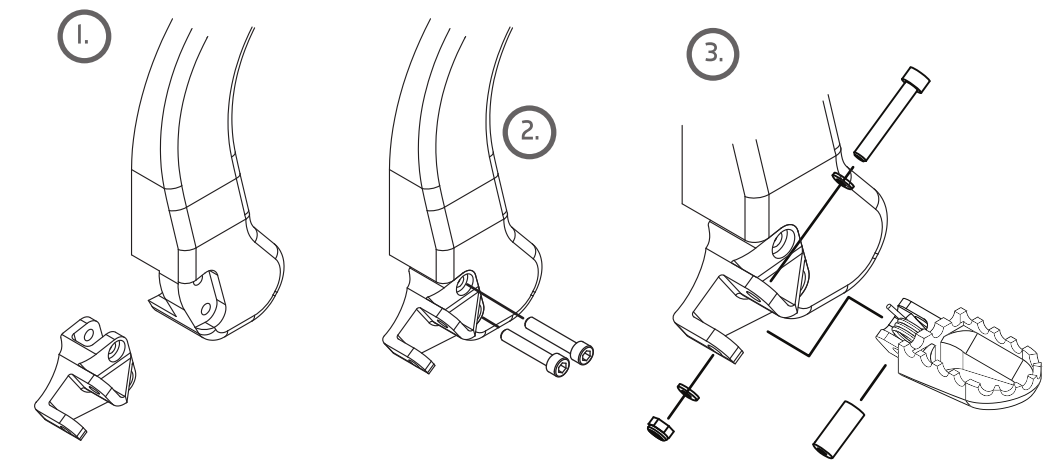
1. 2. 3. assemble on the footrest on the frame as shown in figure using the bushing and the screws provided;
